Portage Creek Sediment Remediation Project Kalamazoo, Michigan

Post-Sediment Removal Structure Feature Assessment Removal Area SA6

F&V Project Number: 809930
August, 2012

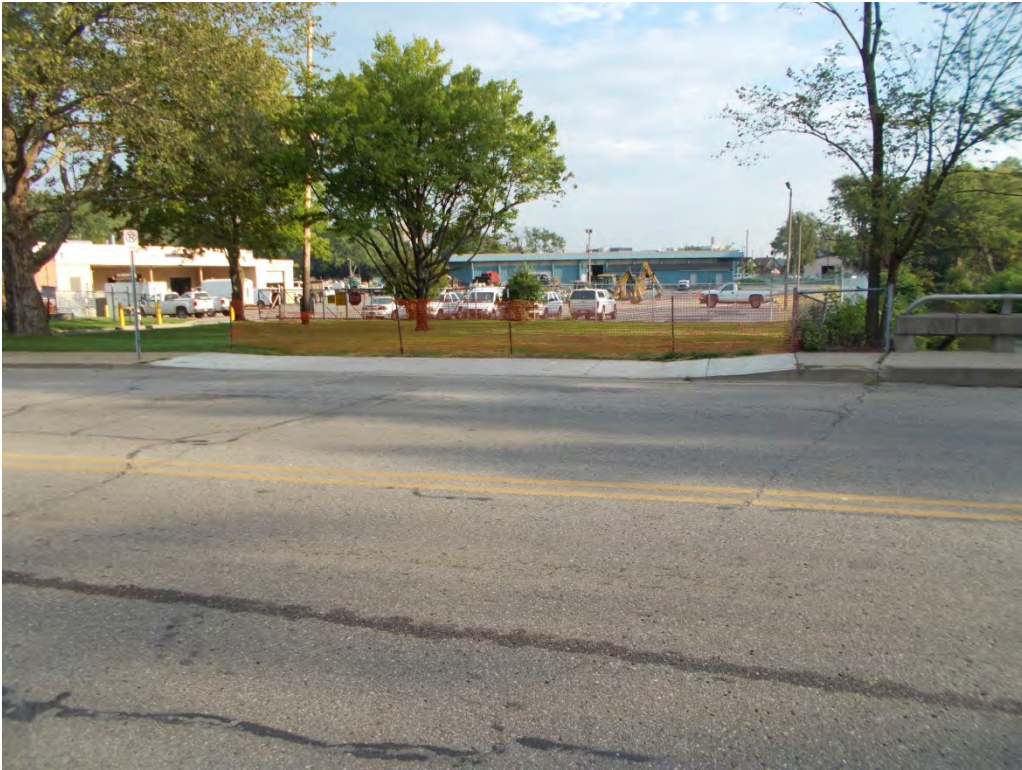
- The northwest curb head has been cut to provide site access for vehicular traffic. The adjacent sidewalk has been replaced. It is recommended that the City of Kalamazoo be contacted to confirm that the curb does not need to be replaced.
- The northwest quadrant has been restored and early grass growth was noted.
- Construction fencing is still in place in the northwest quadrant.

Curb cut for access in the northwest quadrant

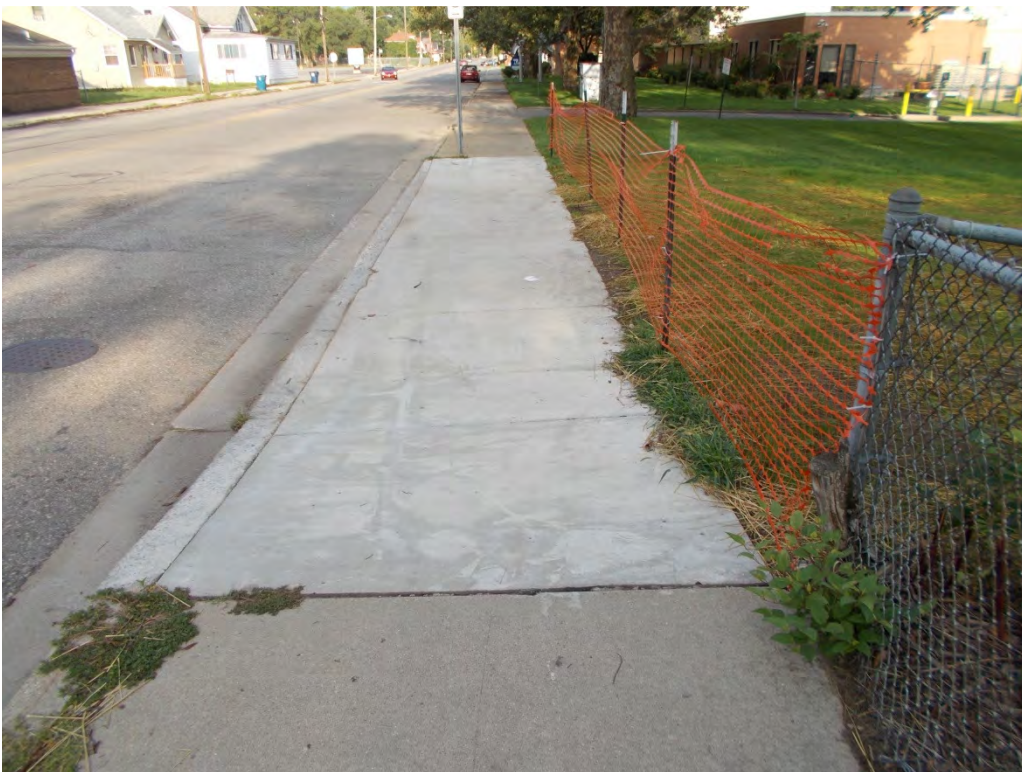
Sidewalk replacement in the northwest quadrant

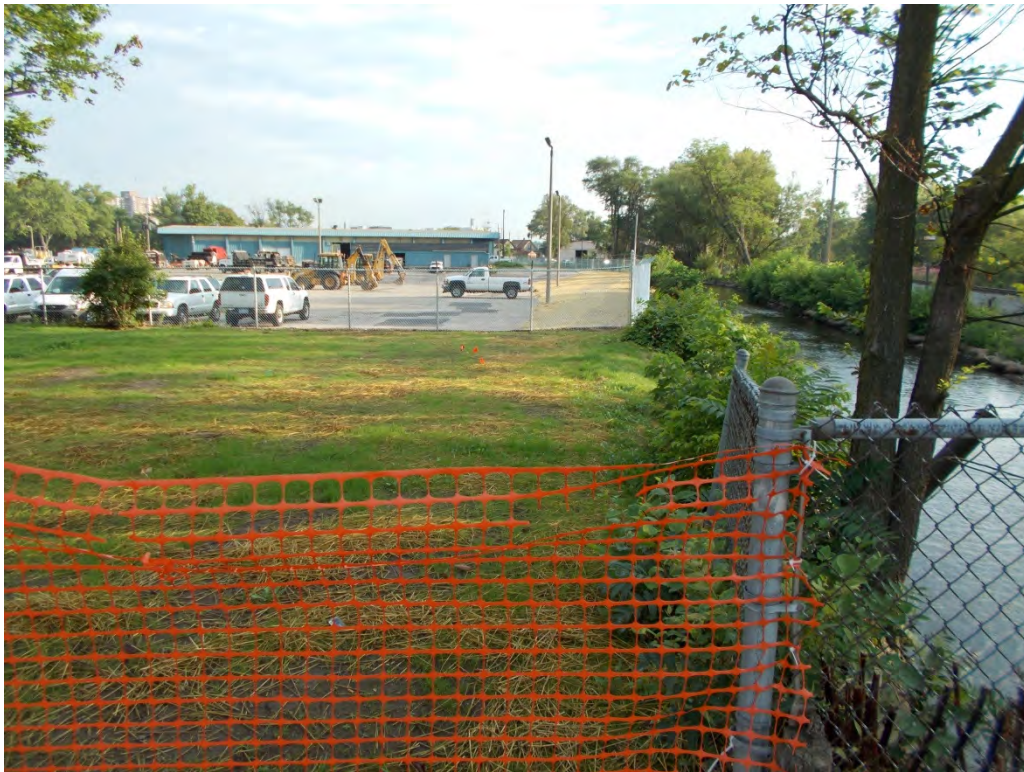
Early grass growth in the northwest quadrant

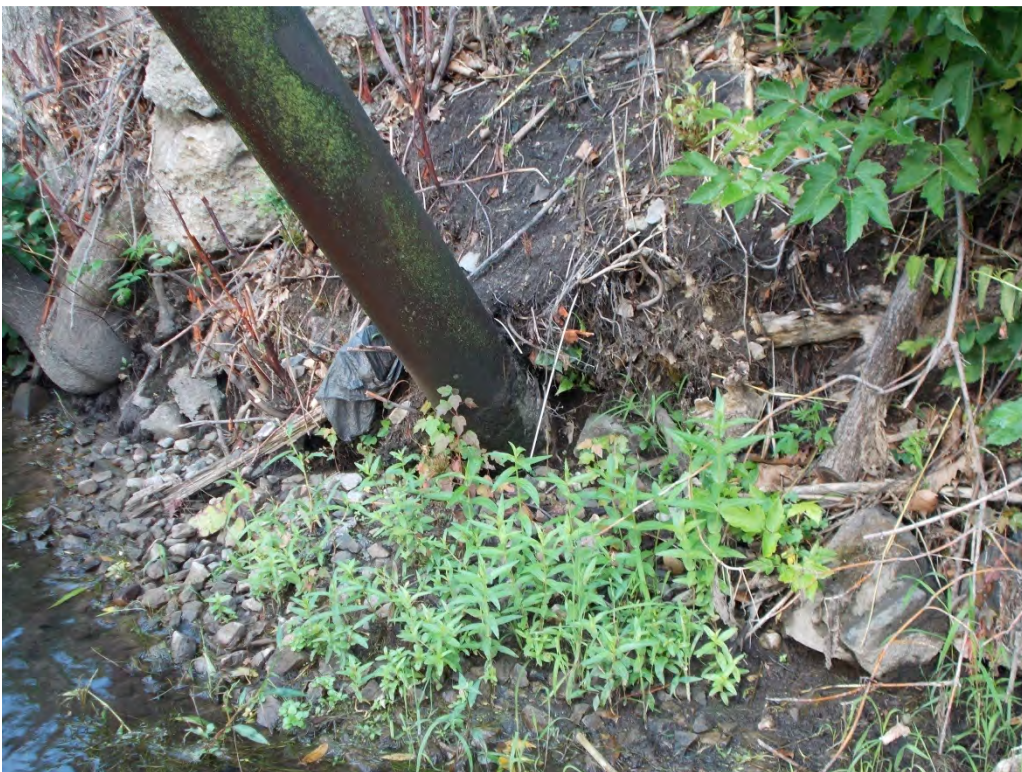
Heavy scaling and bank undermining at the base of the structure

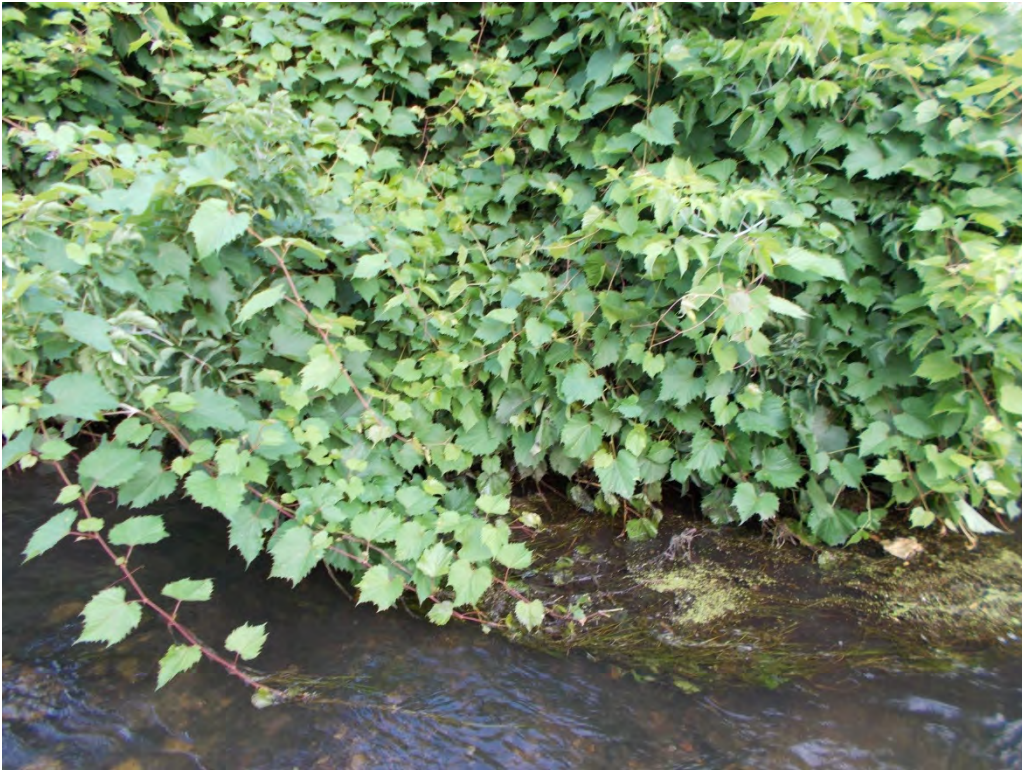
View of the overgrown outlet from the channel

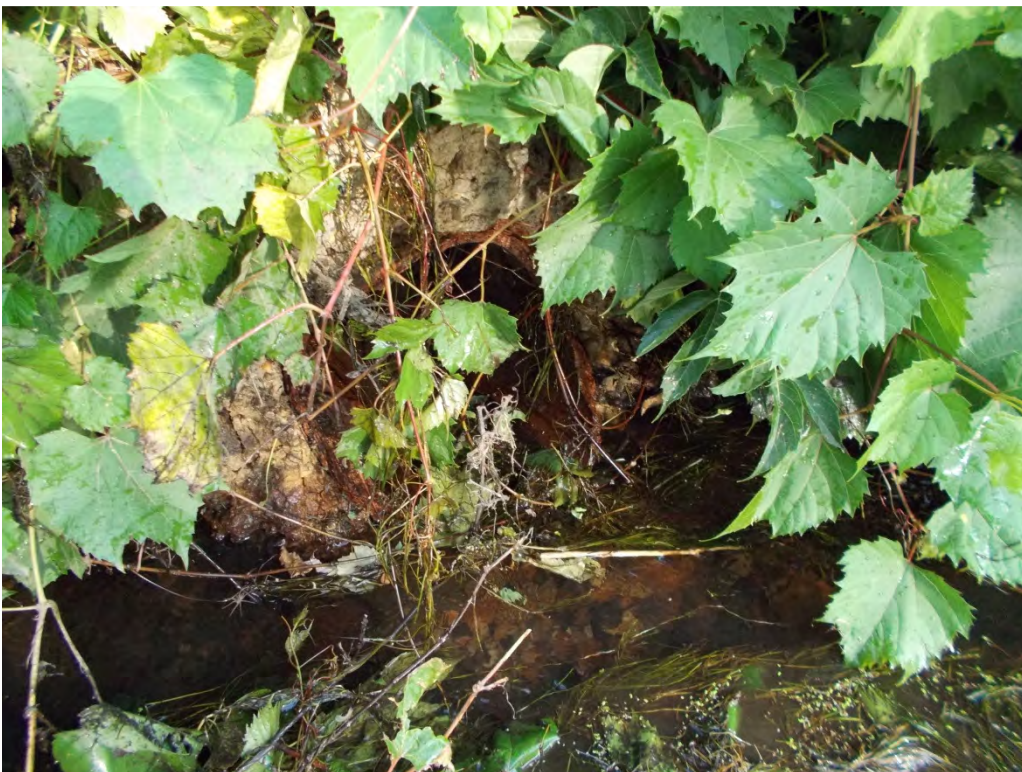
- The structure is severely overgrown with vegetation.
- The end of the headwall and clay pipe appear to have been spalled during sediment removal. It is recommended that the City of Kalamazoo be contacted to determine whether a clean saw cut on the end of the structure is required.

Spalling on end of headwall and clay pipe

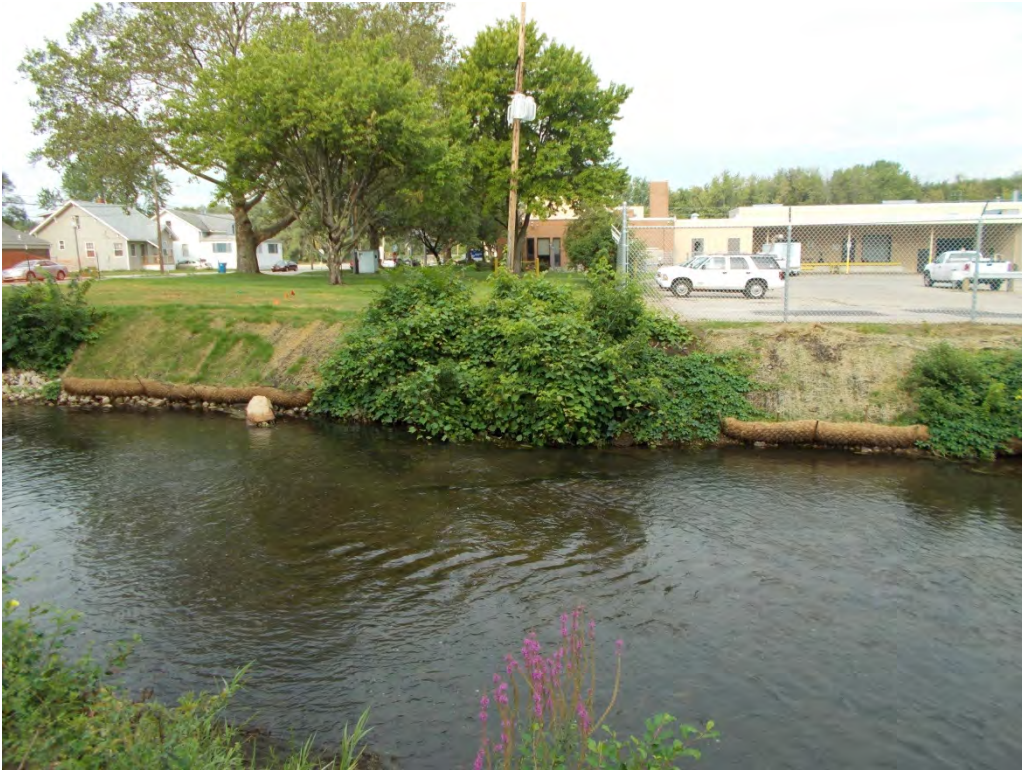
Overall view of the overgrown structure

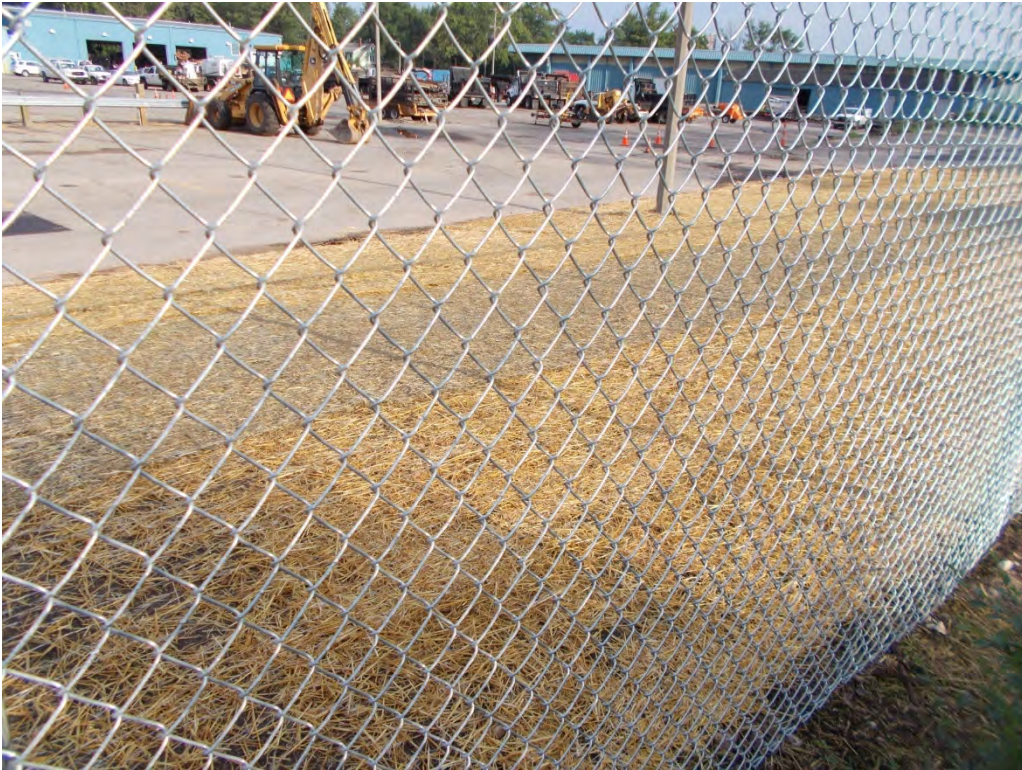
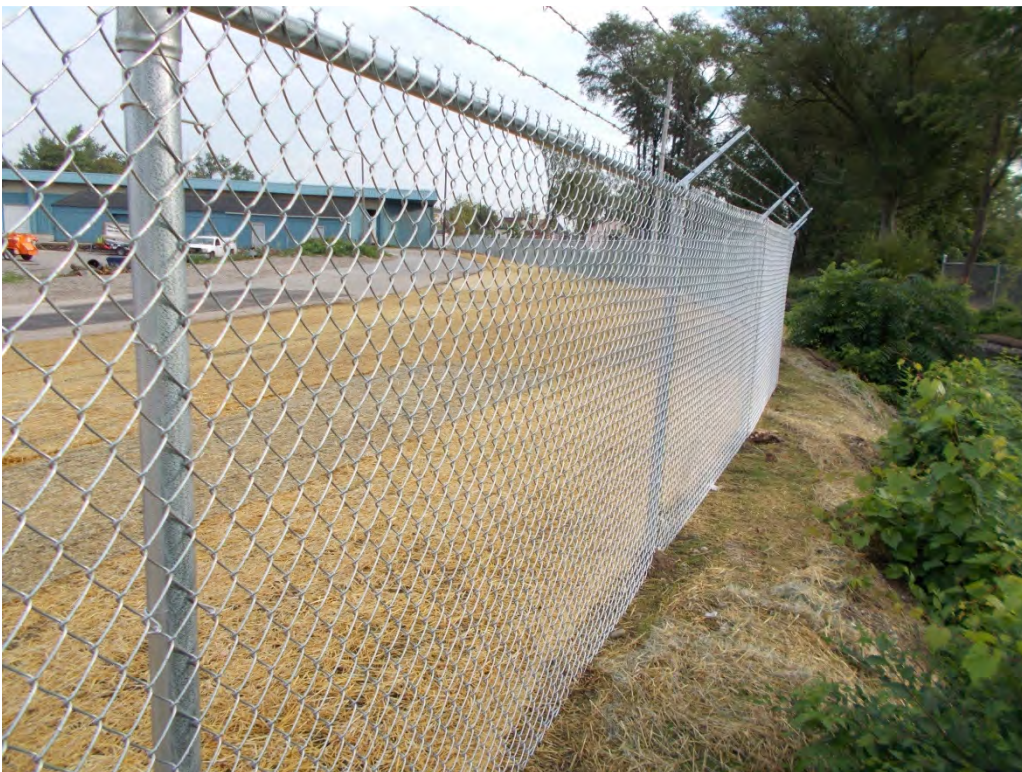
View of the restored area through the new chain link fencing

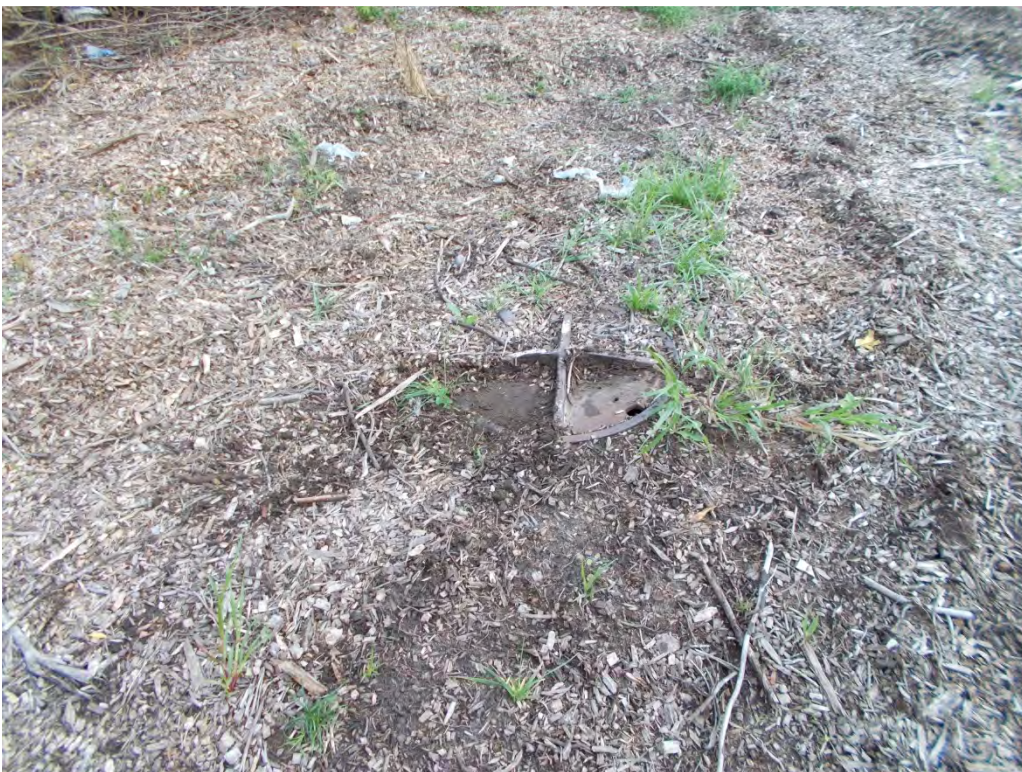
- The area parallel to the creek has been restored, however, grass growth was not yet evident.
- Chain link fencing has been replaced along the west bank of the creek.
- The manhole cover on the east side of the creek was installed upside-down and should be reversed.
- Because the sewer itself is not observable from the surface, it is recommended that it be televised and compared to televising performed prior to sediment removal, if available.

Upside-down manhole cover on the east side of the creek

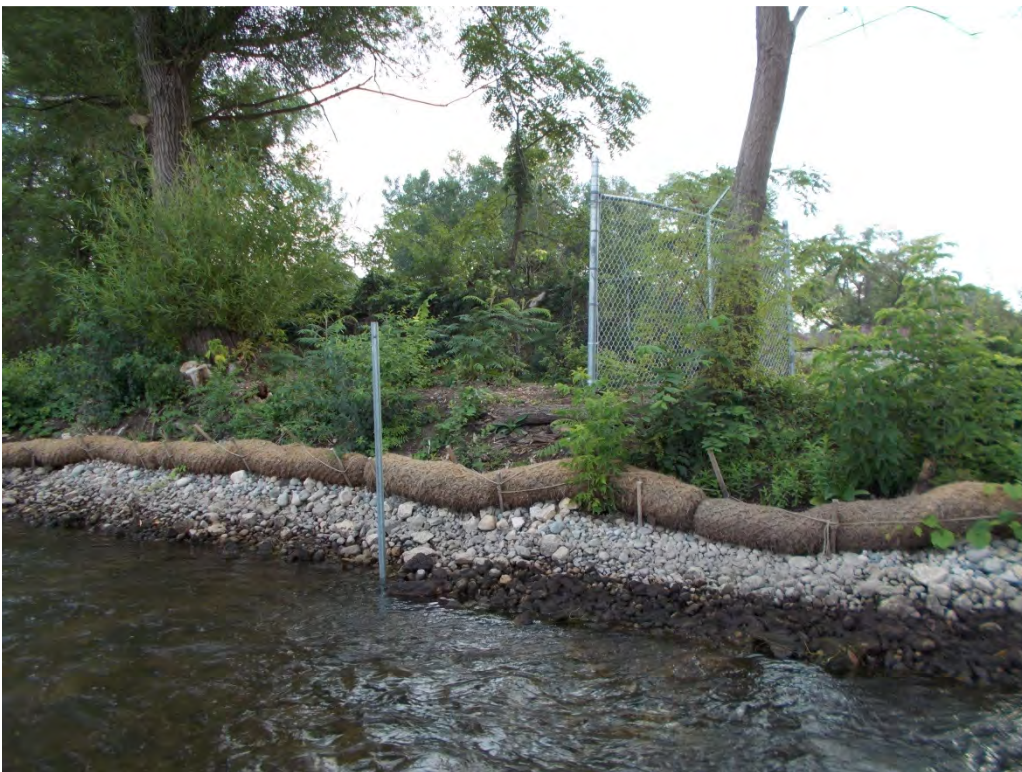
- The fencing has been removed and replaced, however, the end section into the channel was not yet installed at the time of assessment.

Missing end section on new fencing

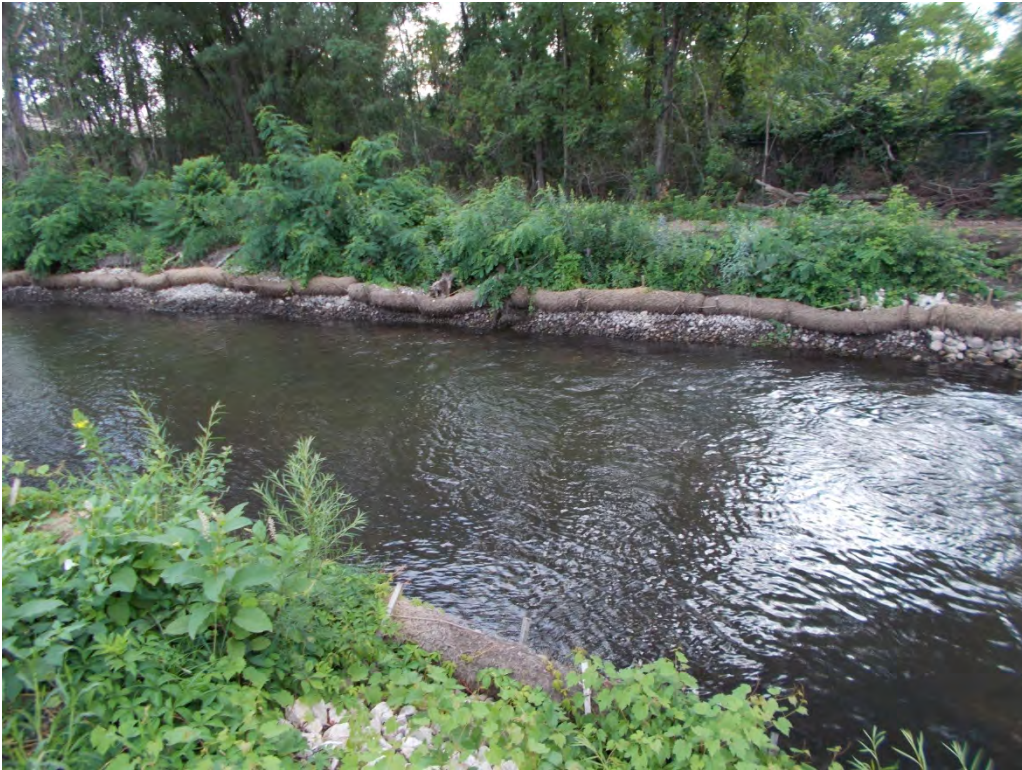
- Structure SA6-S09 was removed during sediment removal.

Bank restoration in area SA6-S09 was located

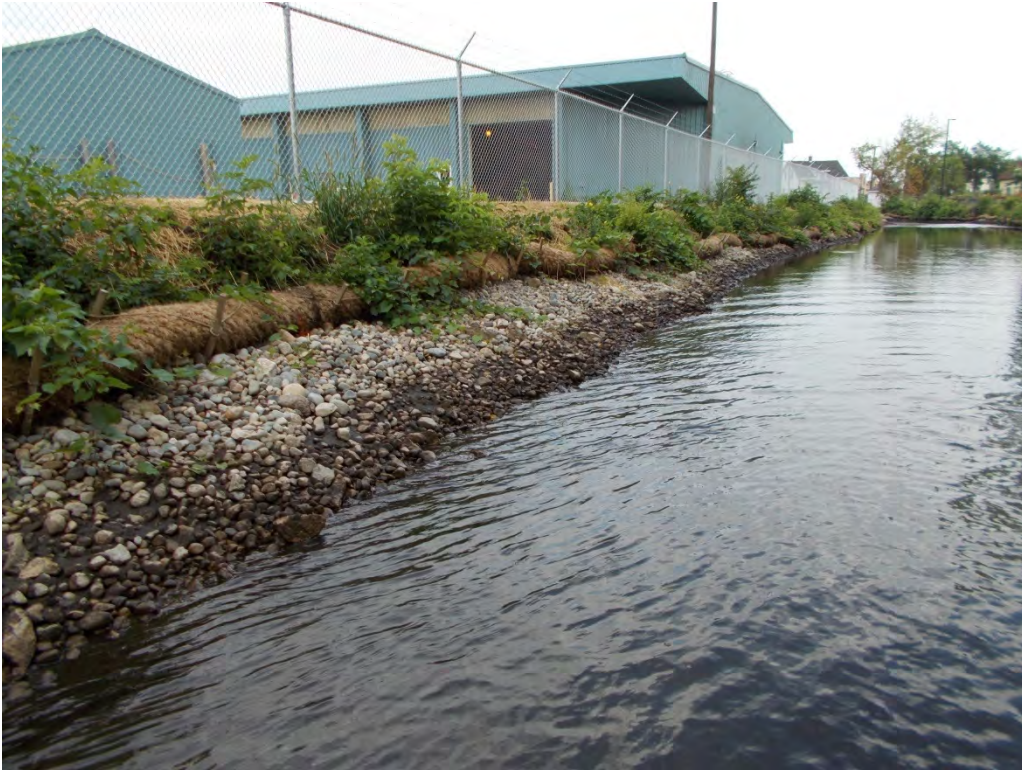
- Structure SA6-S11 was removed during sediment removal.

Bank restoration in area SA6-S11 was located

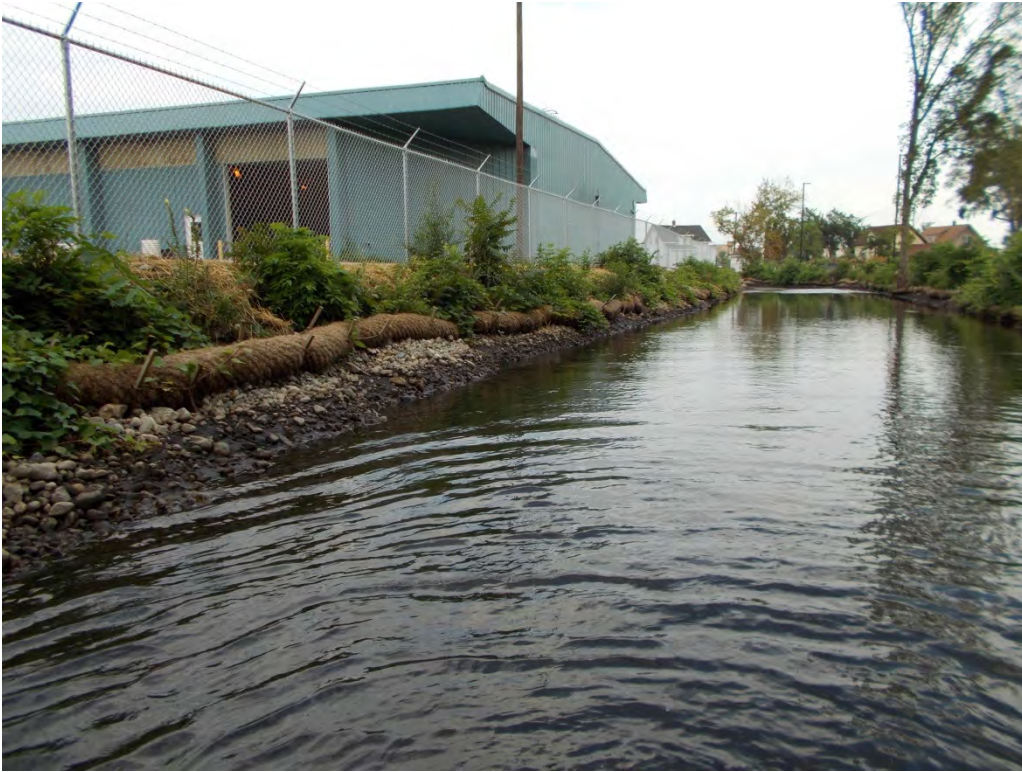
Bank restoration in area SA6-S12 was located

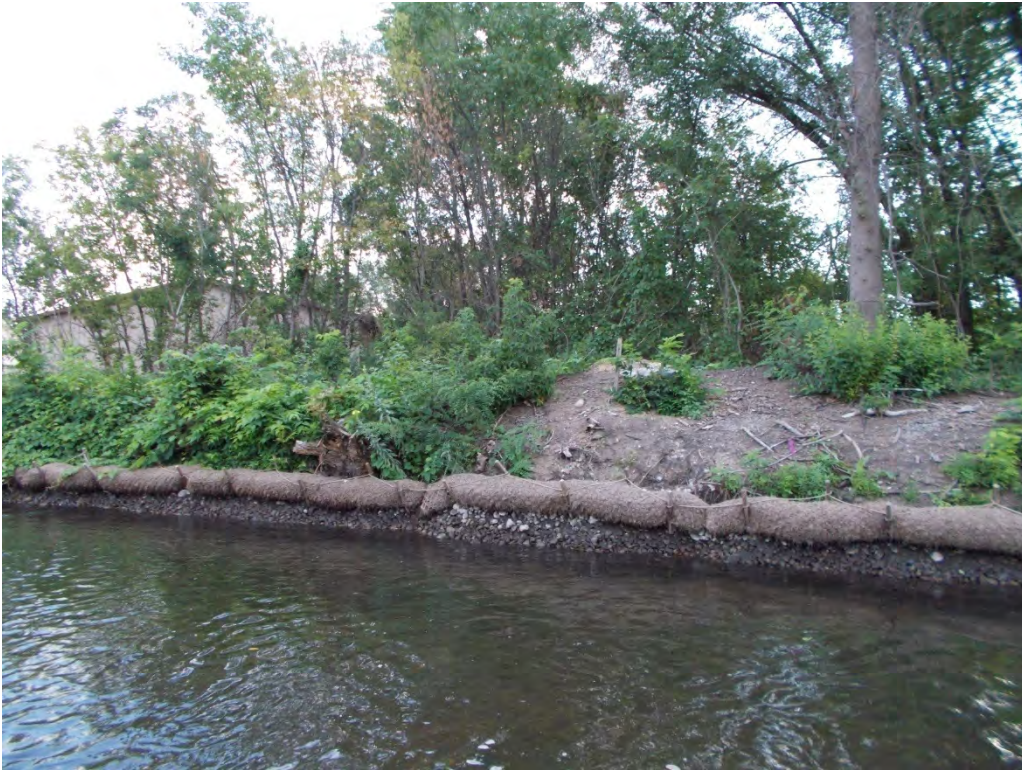
- The chain link fence was removed in conjunction with sediment removal and has not been replaced. It is recommended that the property owner be contacted to confirm that replacement is not required.

Bank restoration in area SA6-S13 was located

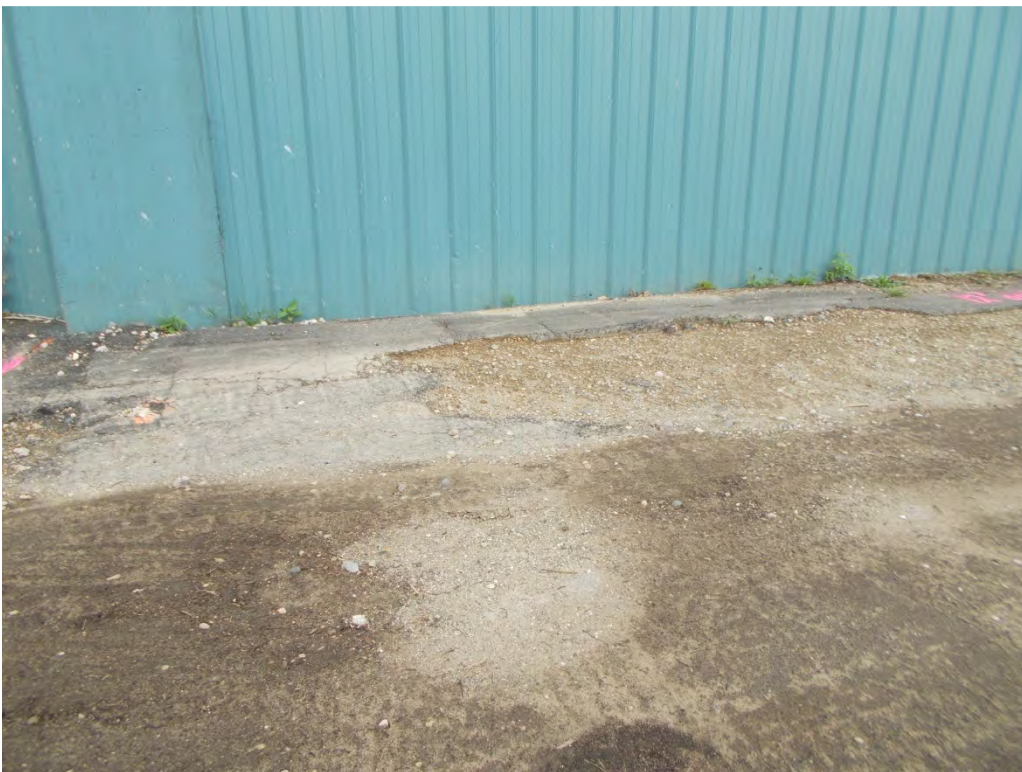
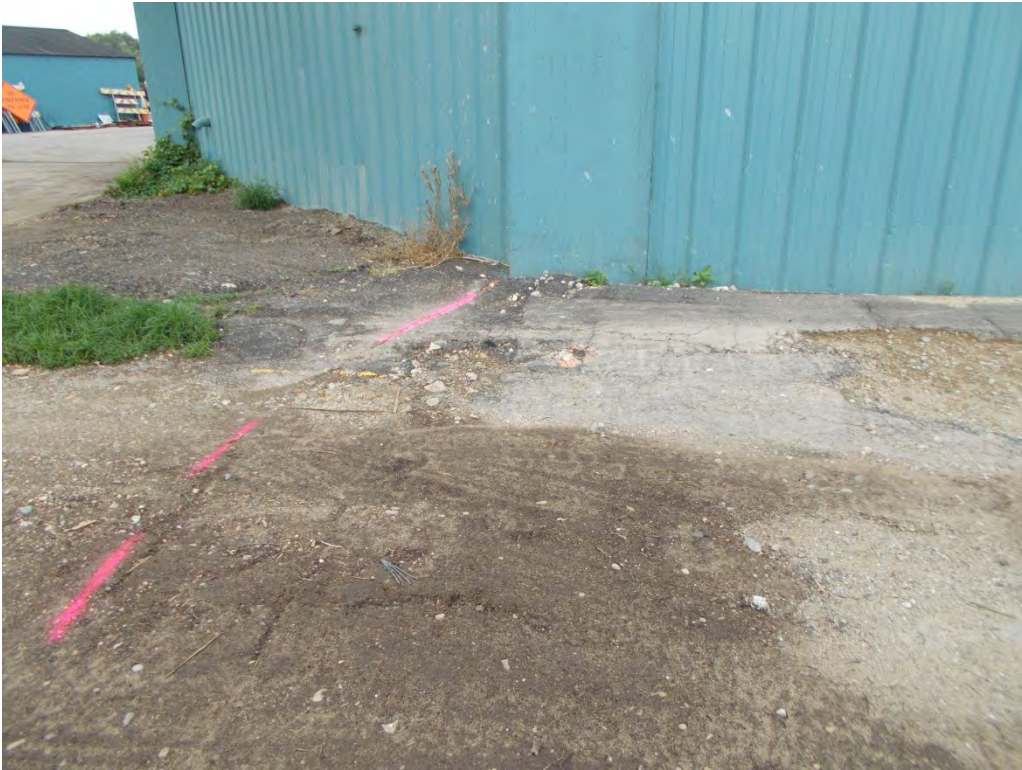
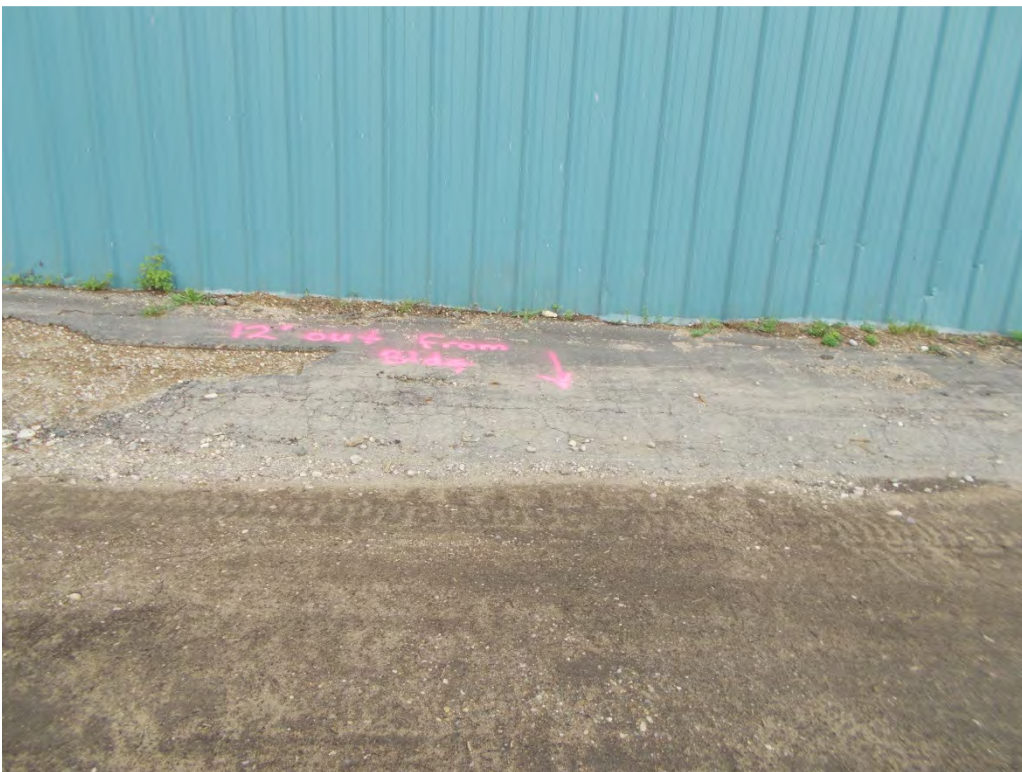
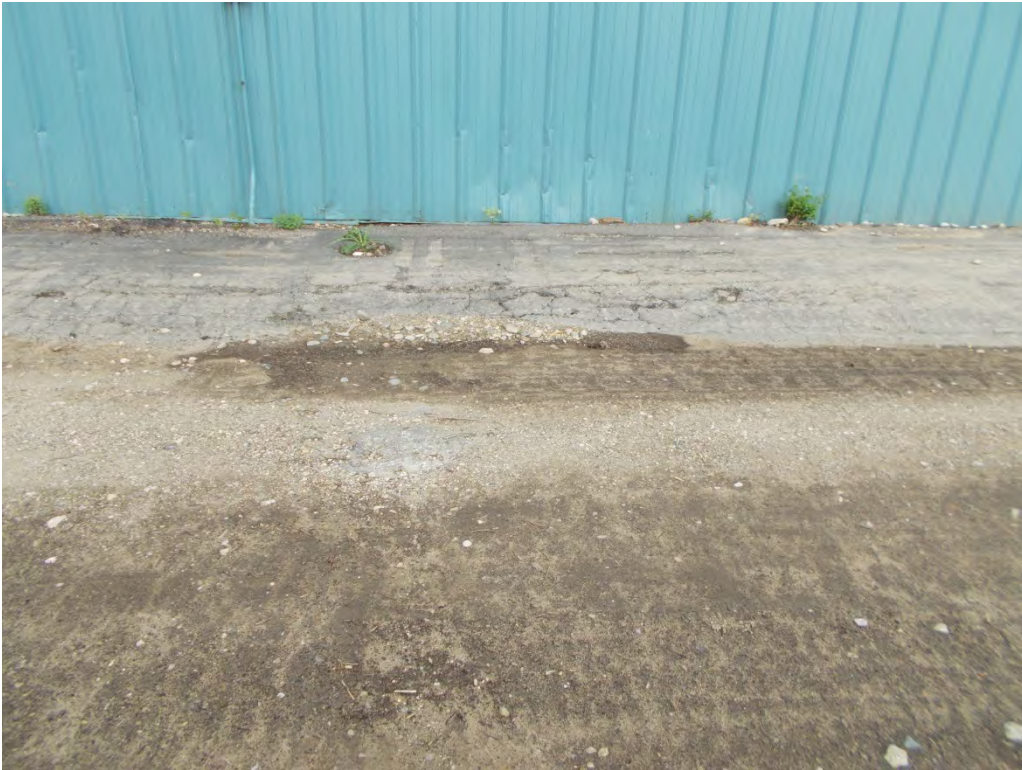
- The building does not appear to have been impacted during sediment removal.
- The asphalt access road appears to have been damaged during sediment removal. We understand that it is being replaced to the limits marked in paint.

Severe deterioration of the asphalt access road

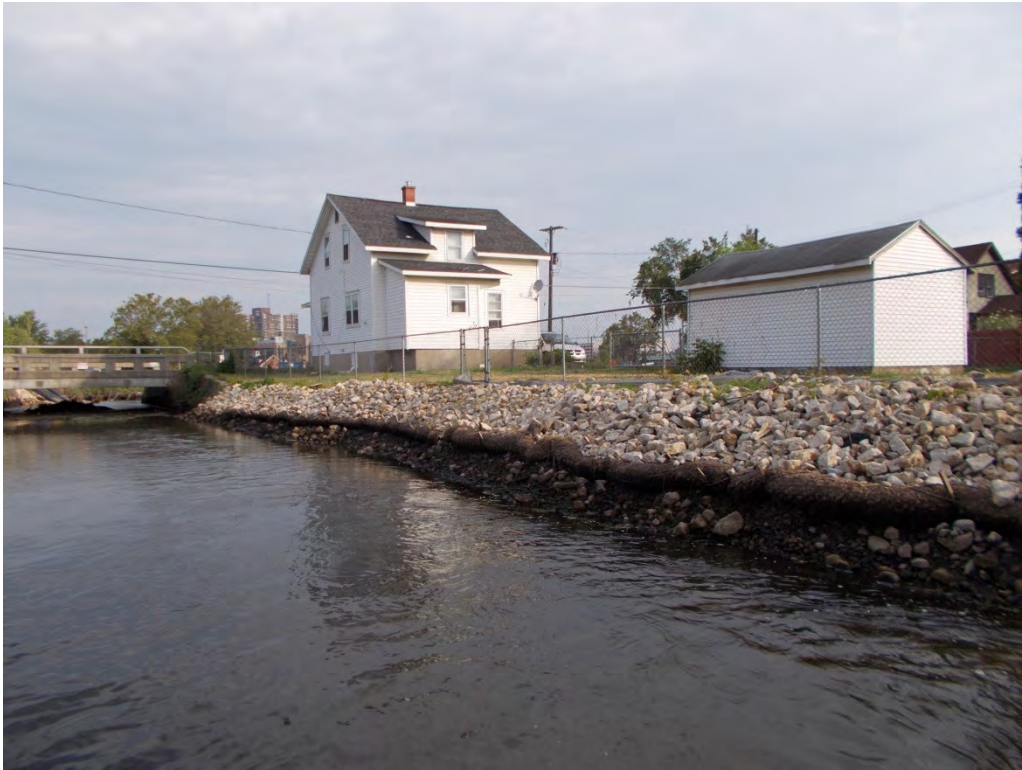
Fence replacement and bank restoration adjacent to structure

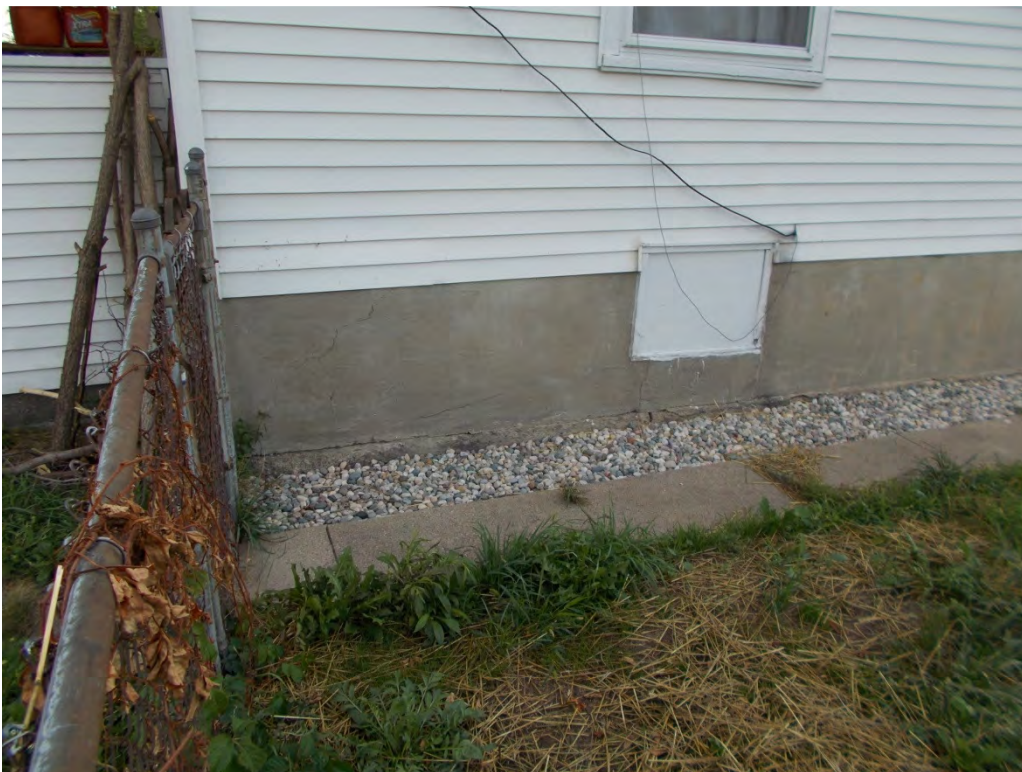
- The fence between the structure and channel has been replaced.
- The bank along the structure has been restored.
- Cracking in the foundation appears to be similar in nature to that observed prior to sediment removal.

Cracking in northwest area of foundation wall

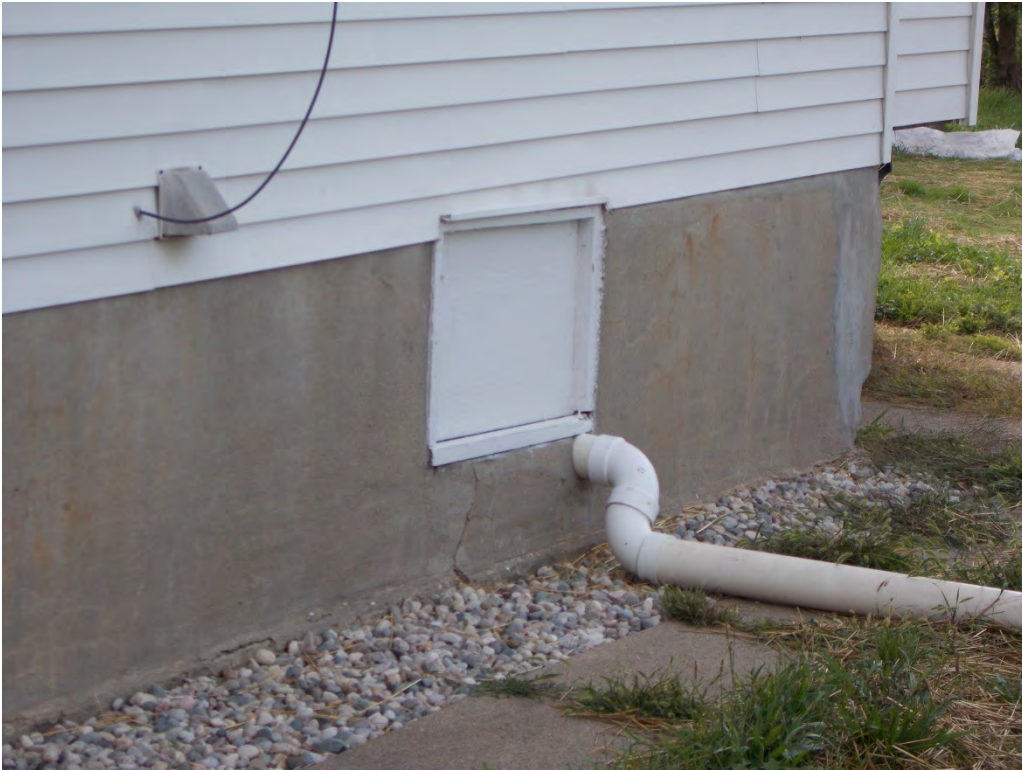
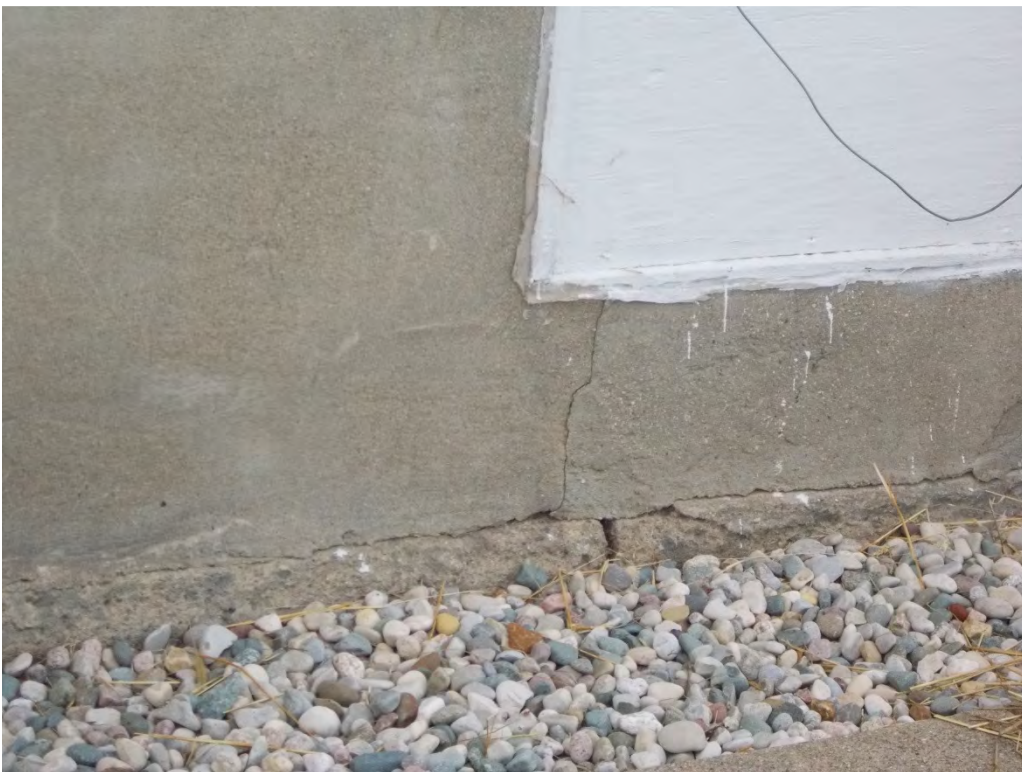
Cracking in southwest area of foundation wall

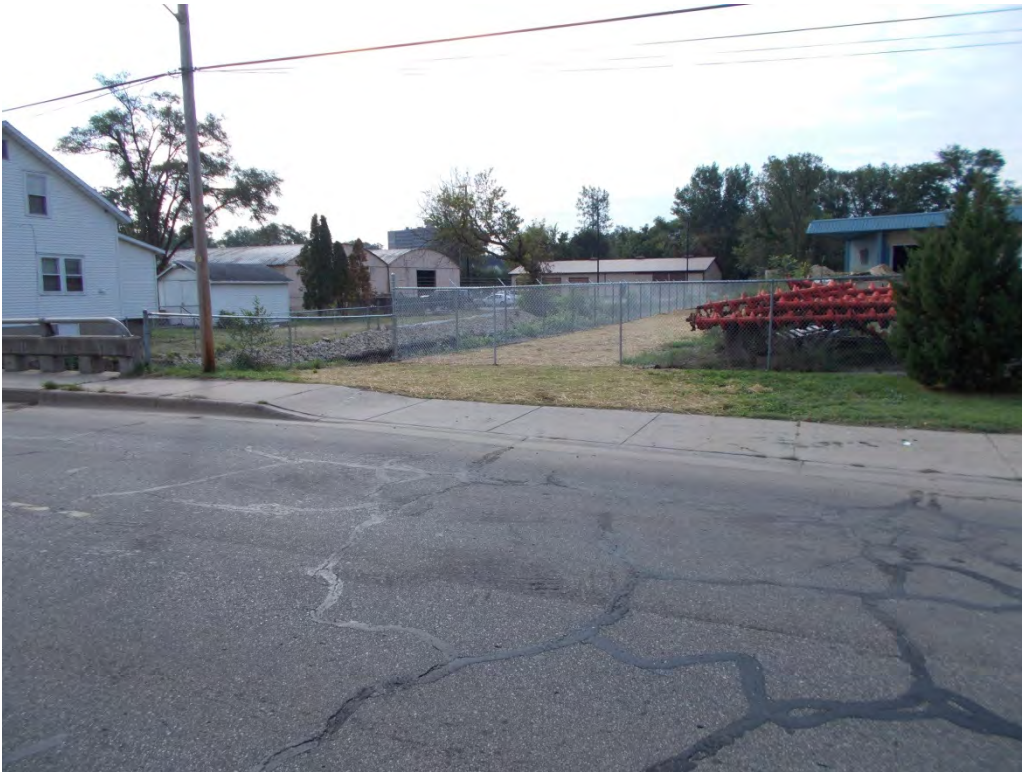
Fence replacement and restoration in southwest quadrant

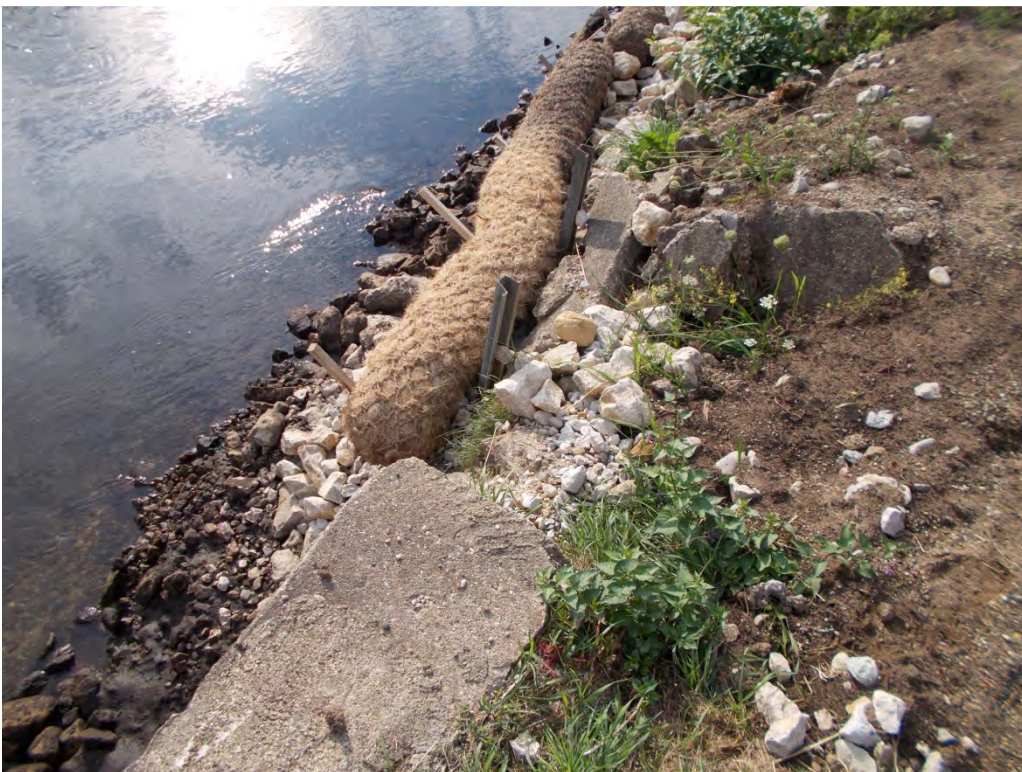
Bank restoration around southwest block wall

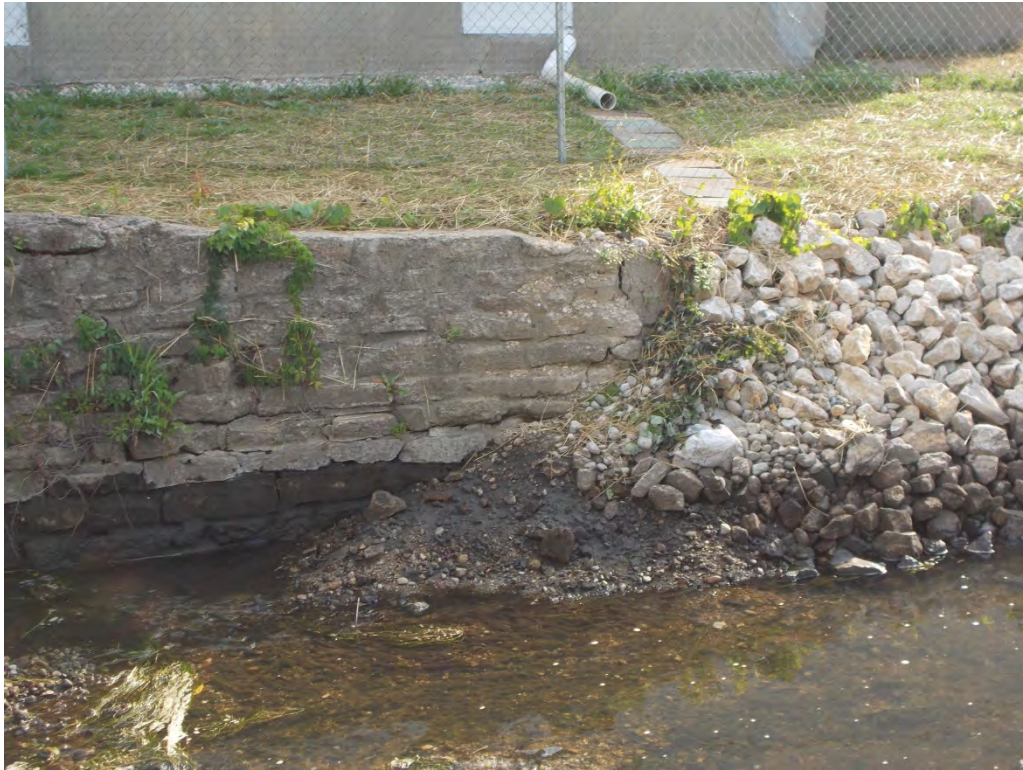
Bank restoration around southeast block wall
